**FF-20260119-001**

# Foundation Inspection Report

*ASCE Level B Evaluation — Elevation Survey & Analysis*

Single-Family Residence · Built 1978 · 1,850 sq ft

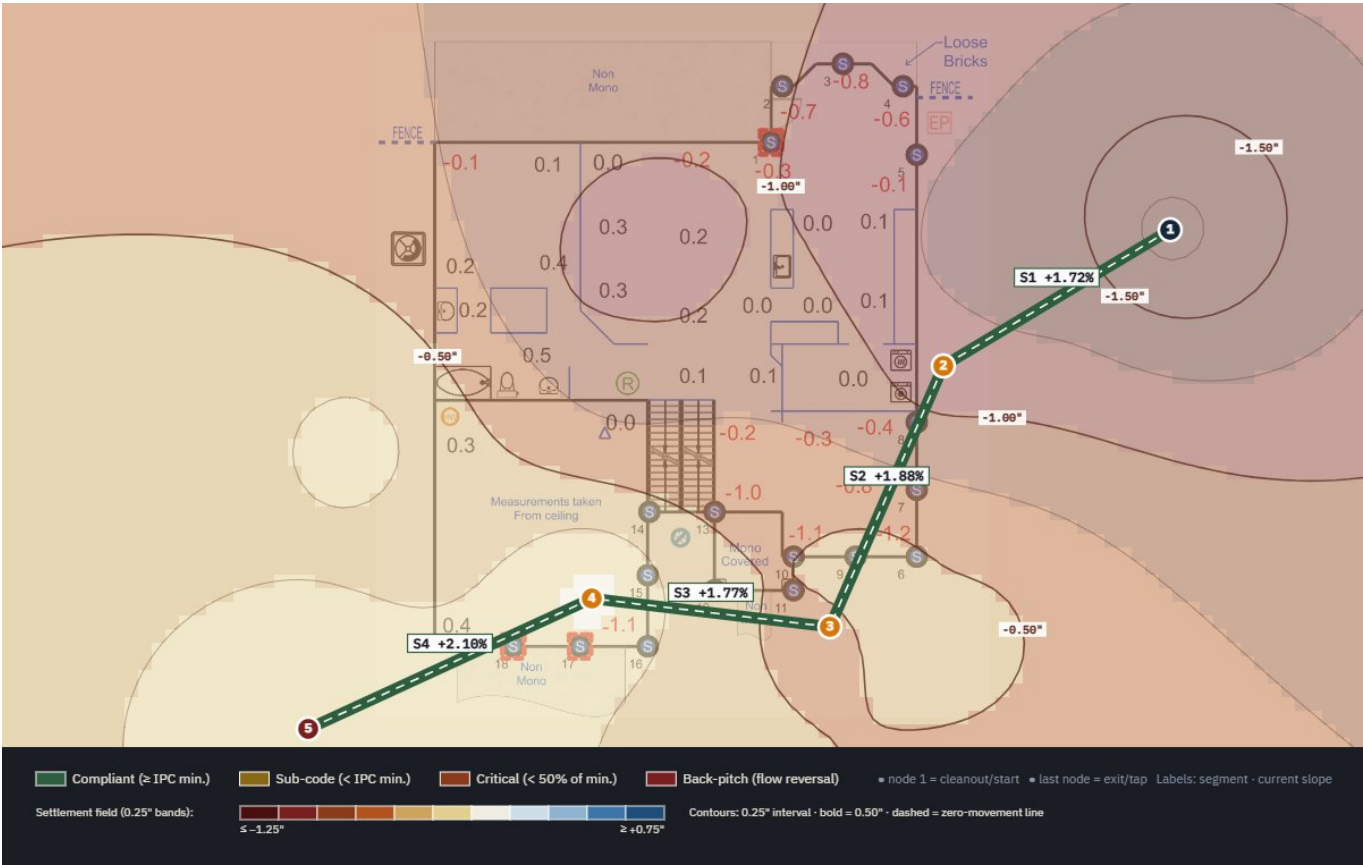
Exhibit A — Sewer routing overlaid on the floor plan. Segment color indicates slope status relative to IPC Table 704.1 minimum; labels show computed current slope per segment.

Moderate finding: 0 sub-code segment(s); peak computed joint-stress index 71 (relative scale, see § 3.6 methodology). A CCTV scope by a licensed plumber would document the current pipe condition; remedial scoping is reserved to others.

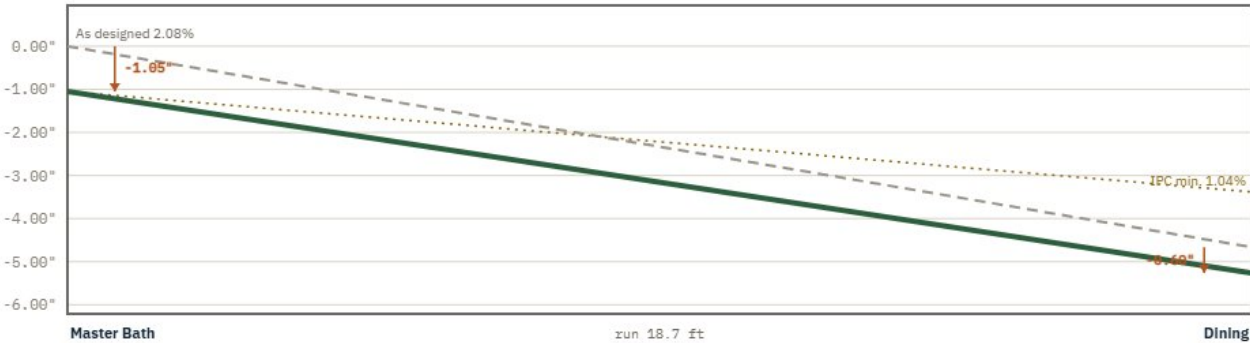
SEGMENT 2 Master Bath → Dining  
Vertical exaggeration x8

COMPLIANT +1.88%

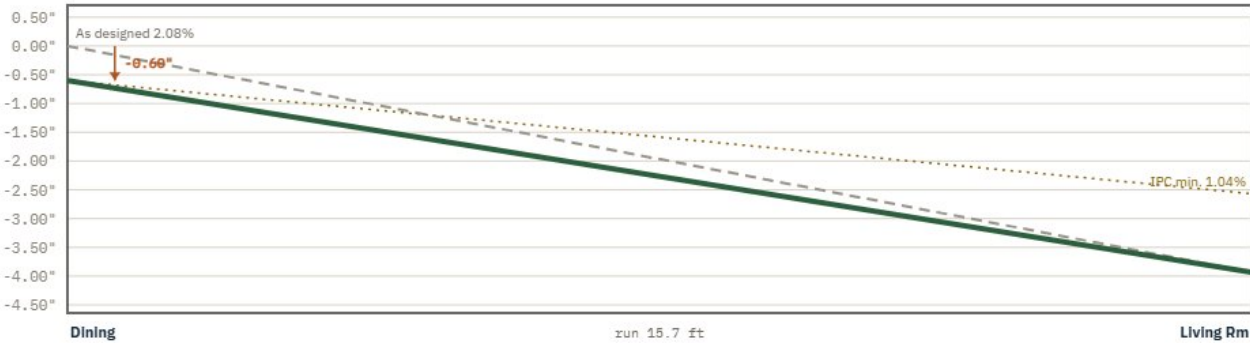
SEGMENT 3 Dining → Living Rm  
Vertical exaggeration x9

COMPLIANT +1.77%

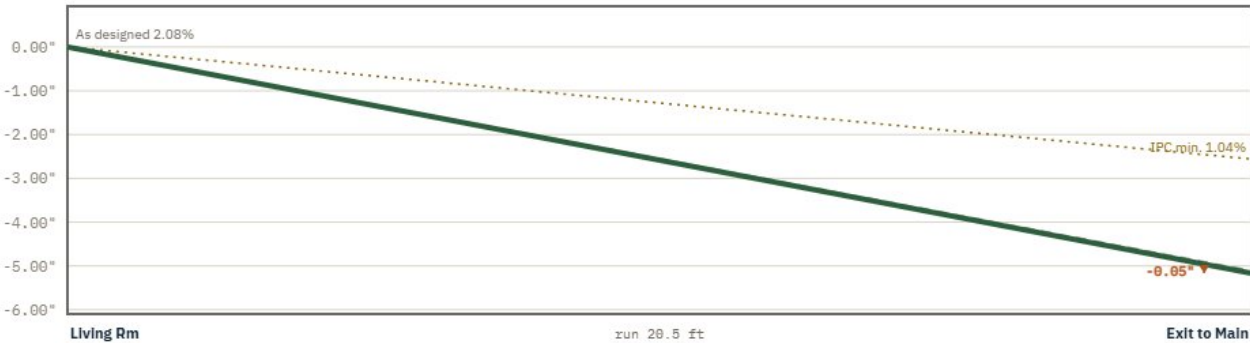
SEGMENT 4 Living Rm → Exit to Main  
Vertical exaggeration x9

COMPLIANT +2.10%

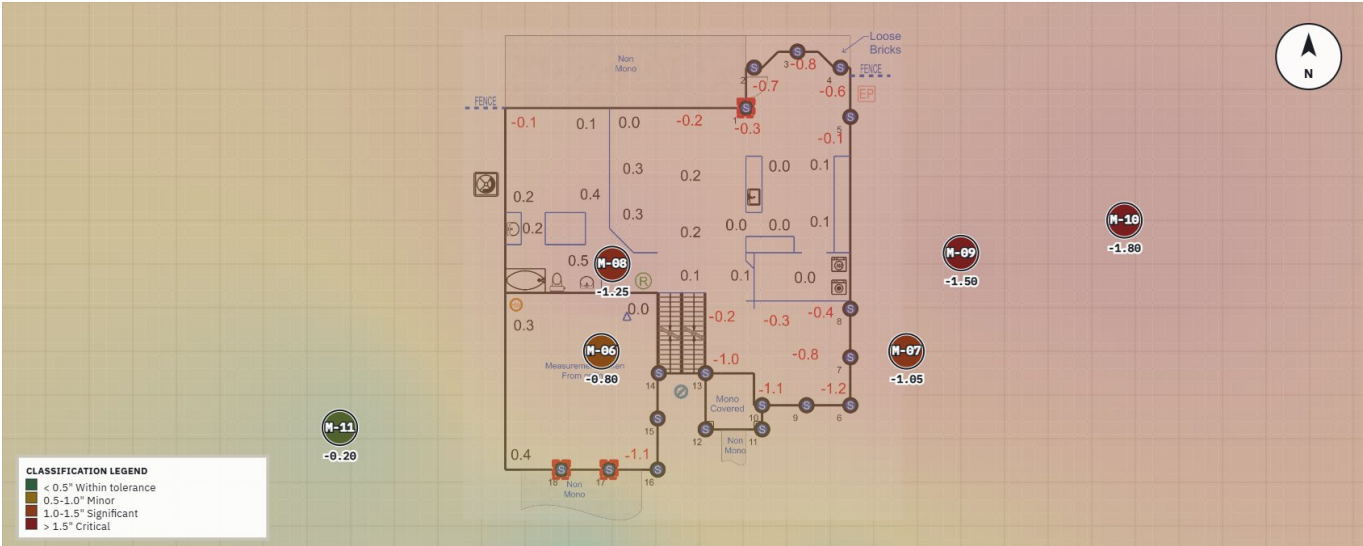
Maximum measured differential: 1.80 inches

Our inspector recorded relative elevation measurements at 12 points across the foundation slab. The map below shows where each measurement was taken and the relative settlement at each location. Color-coded markers indicate severity: lower (settled) areas appear in red, baseline areas in green.
